NONDESTRUCTIVE EVALUATIONS OF COM-
POSITE HEATSHIELD MATERIALS BEFORE
AND AFTER AN UNDERGROUND NUCLEAR
EXPOSURE

James R. Brown, Jr., et al

Southern Research Institute

AFWL-TR-73-247

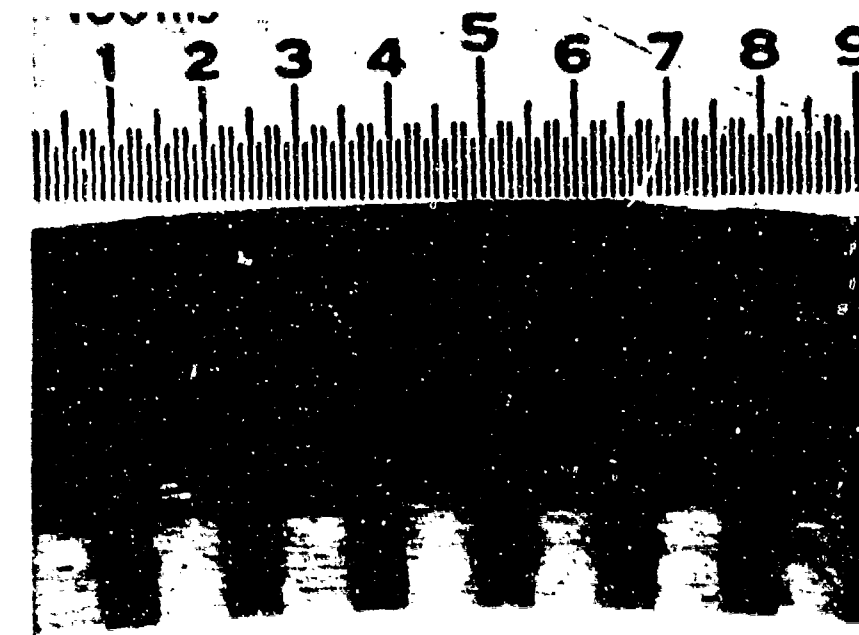
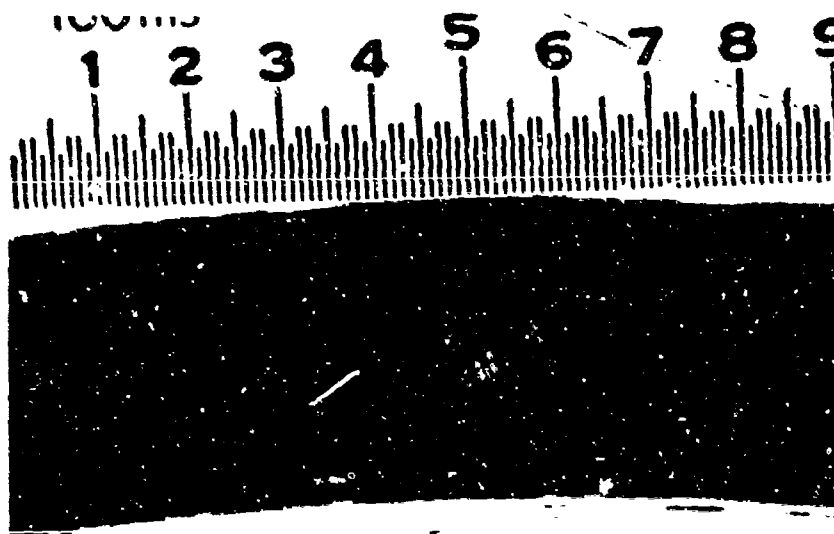
Figure 27. Photograph Showing Typical AVCO 3DC/QP
in Rings 83301-202B and 83301-305-5

The material background was generally considered similar to AHP 3DC/QP material reported in AFML-TR-72-160. For Ring 3, the material had lower porosity and straighter circumferentials than the AHP material, Figure 26. For Rings 83301-202B and 83301-305-5, the material had an extremely high residual porosity along radials and between axials, Figure 27. Also, for these rings, missing pieces of axials and circumferentials from machined surfaces and residual porosity between radials and axials at the inner surface were typical of the material, Figures 26 and 27.

Extremely high
residual porosity
along radials and
between axials

Extremely high residual porosity
along radials and between axials

Note: Missing pieces of axials and circumferentials typical on outer and inner surfaces

Residual Porosity Between One Side of Radial and Axial-Typical for Inner Surface

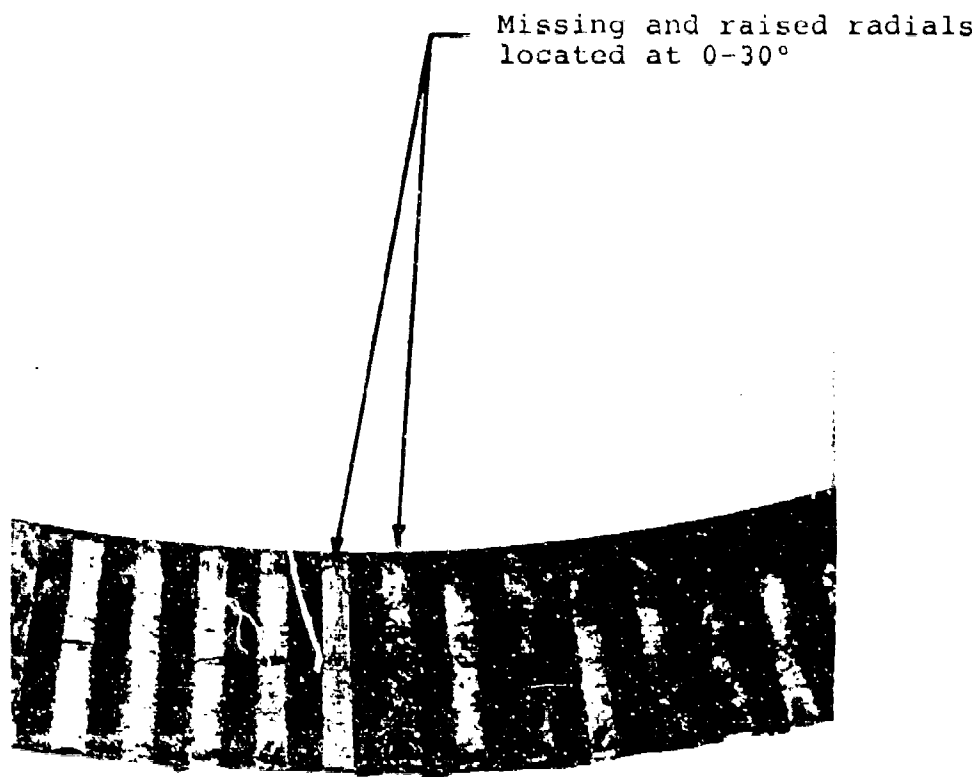
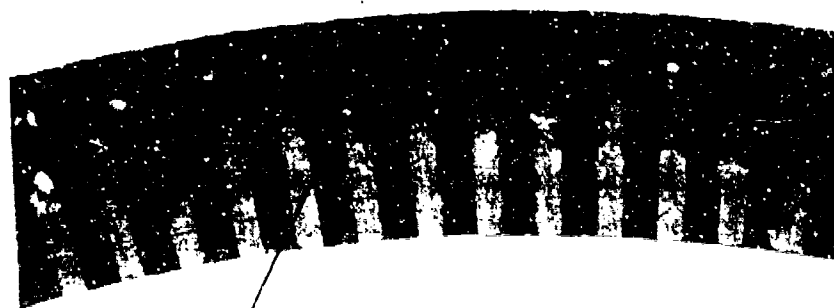
Figure 36. Photographs Showing Structural
Change After Exposure in Ring
1109 -35-3 from AVCO 3DCC

Structural change was visually apparent in both rings. Photographs showing the as-received rings are given in Figures 33 and 34. Generally, for both rings, the change consisted of raised or recessed and missing radials, cracking along local preexisting circumferential delams completely around the ring,

spalled sections of matrix and circumferential reinforcement (circs) over radials in edges, yarn lift from the front face, and discolorations (dark) on the front face. These and other changes are detailed in Table 5 and Figures 35 and 36. Absorption of trimethylpentane into edges of both exposed rings was higher in the exposed zone than out of the exposed zone. The only change indicated by axial X-ray was a 1-1/2-inch long circumferential low-absorptive alignment at 315°.

Cracking Along Pre-existing
Circumferential Delaminations
